The lifeboat imbroglio

Captain Paul Drouin MNI

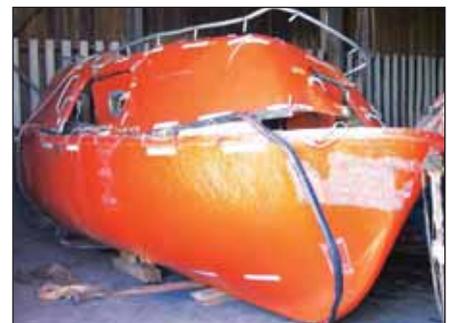
▲ Figure 2: A confused heap or tangle photo from Australian Transport Safety Bureau report 208 - *Lowlands Grace*
